No. 14

British European Airways Corporation, Vickers Viscount, G-ALWE, crashed while approaching to land at Ringway Airport, Manchester on 14 March 1957. Report released by the Ministry of Transport and Civil Aviation (UK) CAP 147

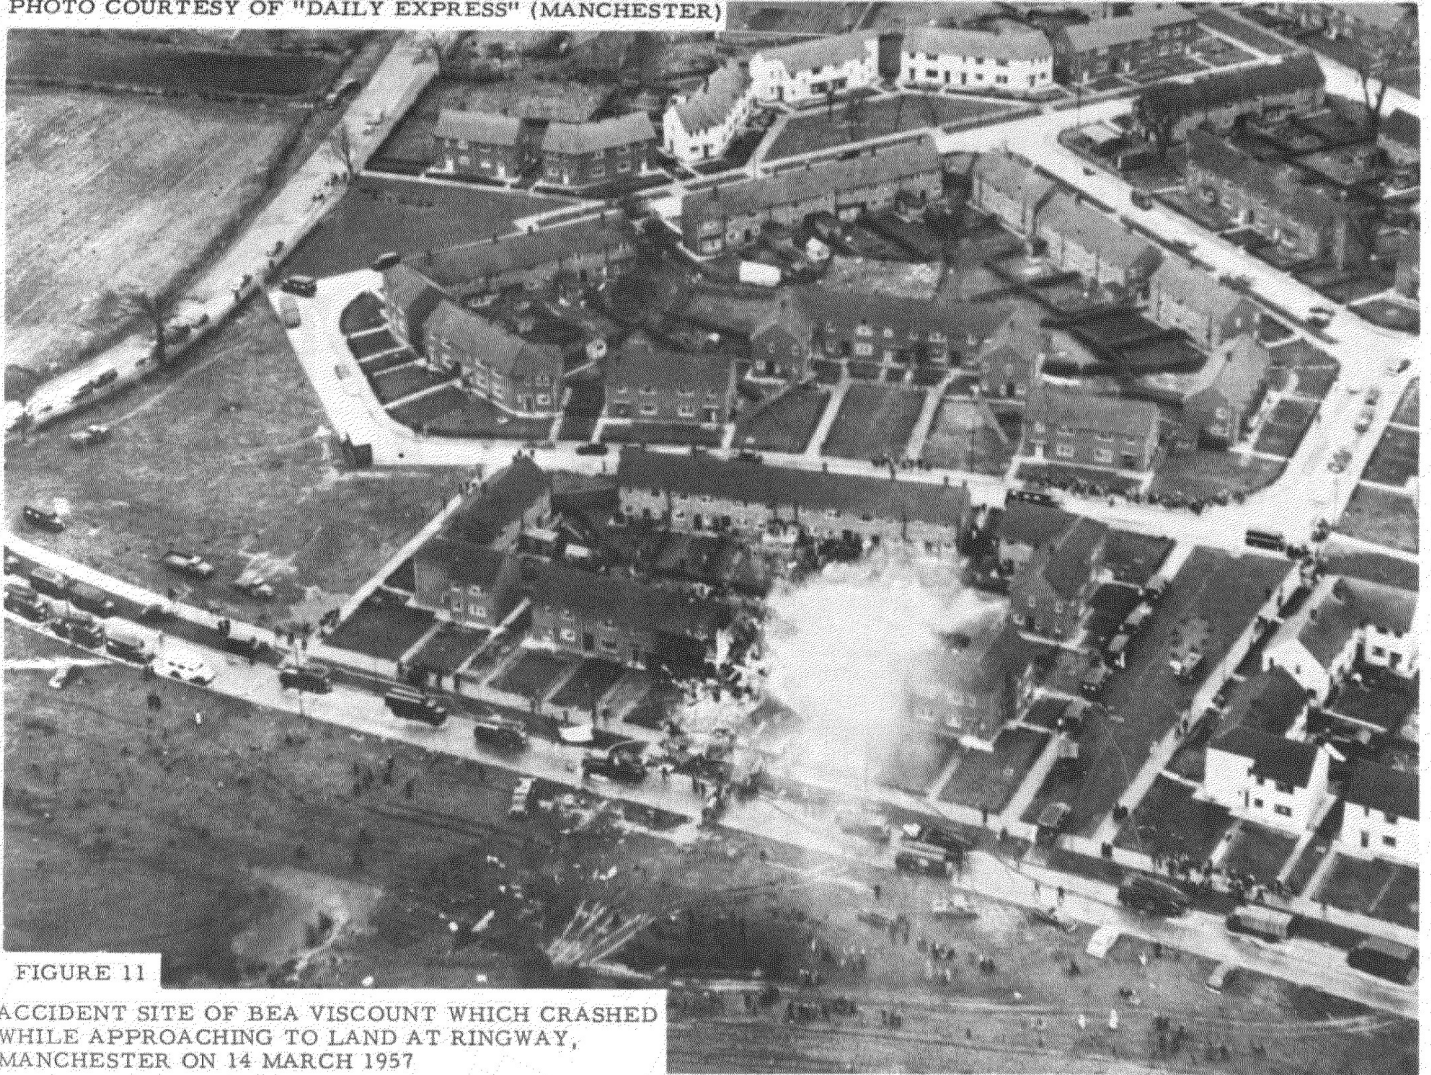
FIGURE 11

The aircraft was reaching the end of a scheduled passenger-carrying flight from Schiphol, Amsterdam, with a crew of 5 and 15 passengers aboard. Until the aircraft was roughly a mile from the threshold of the runway it was apparently making a perfectly normal approach, then it made a banked turn to starboard and continued to descend until the starboard wing tip struck the ground. With the starboard wing furrowing the earth and breaking up, the aircraft, obviously completely out of control, went on until it struck some houses, demolishing two of them (in one of which a woman and her infant son were killed). The aircraft came to rest in the ruins of the houses and immediately caught fire and set fire to the houses. All the crew members and passengers were killed in the accident. The position of the final crash was about 900 yards short of the runway and 200 yards to the right of its extended centre line.

ACCIDENT SITE OF BEA VISCOUNT WHICH CRASHED WHILE APPROACHING TO LAND AT RINGWAY, MANCHESTER ON 14 MARCH 1957

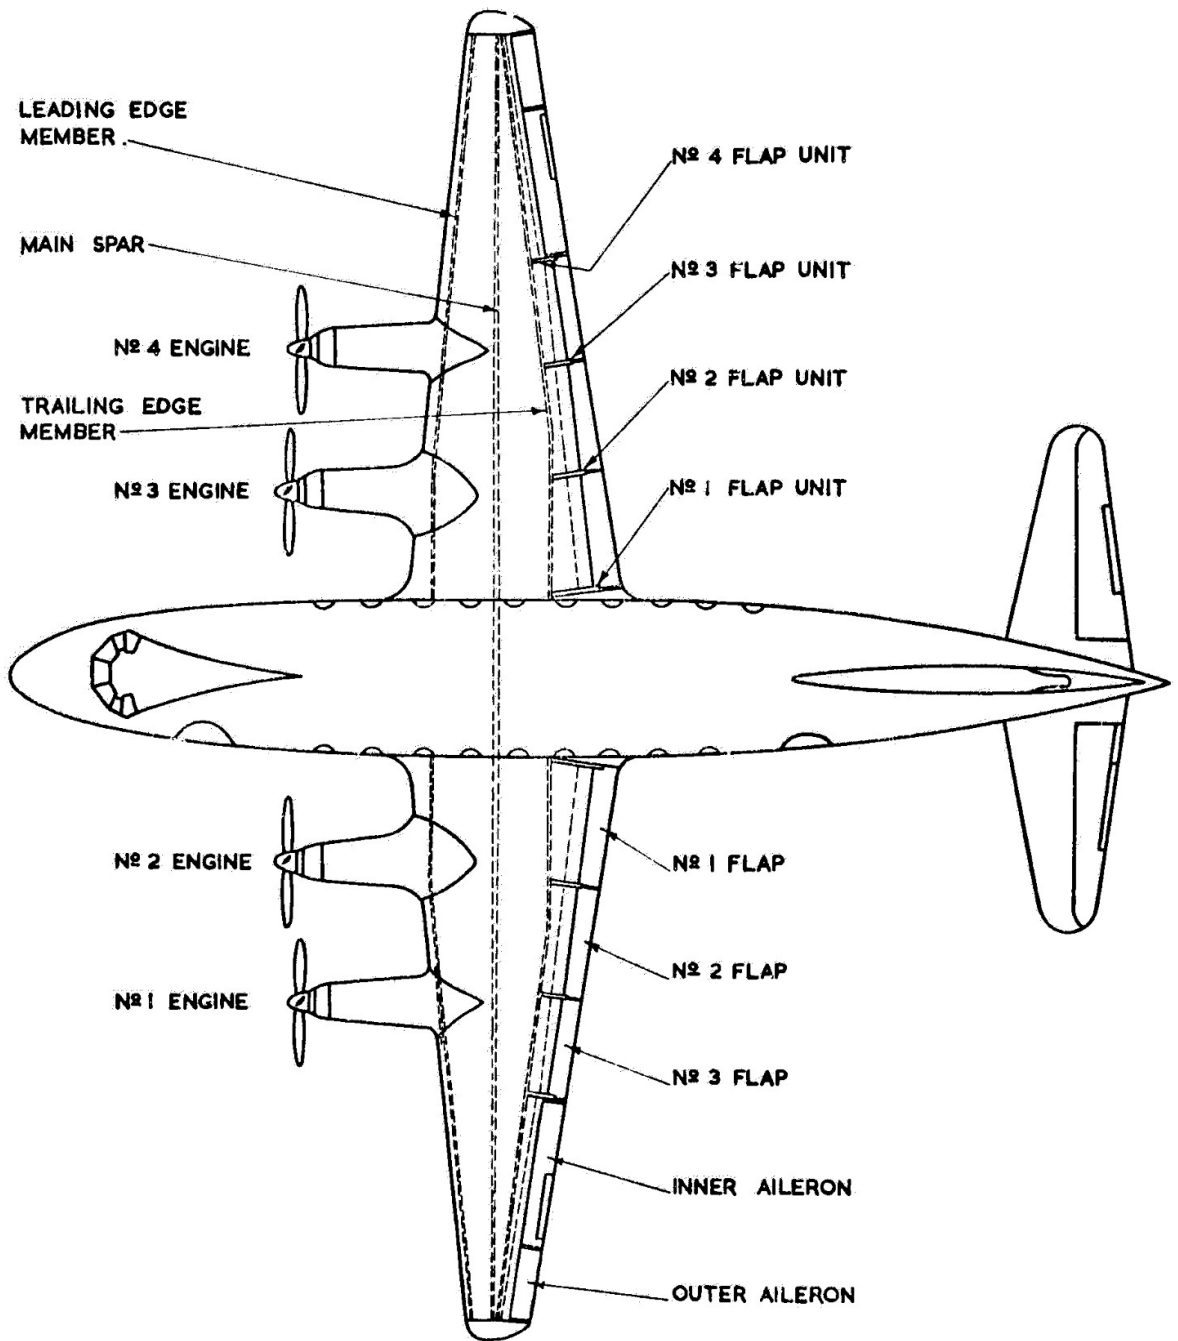
FIGURE 12

One witness said that when the aircraft was over a point which is rather less than a mile from the threshold and was perhaps five hundred to six hundred feet high, he could see it from directly astern and observed that the two inboard starboard flaps appeared to rise above the wing (see Figure 12). It appeared to him that the centre joint between these flaps had come adrift from the wing. One moment the flaps were normal and the next they were bent. The angle of the flaps made it appear that they had risen above the trailing edge of the wing giving "a sort of roof effect". The port flaps remained

normal. It was immediately after the movement of the starboard flaps that the aircraft first banked to the right. He looked to see if the ailerons moved but could not see any movement. There was no evidence from any eyewitness that the ailerons were operated at all after the first turning and banking movement began. The witness estimated the time interval between the bending of the flaps and the final impact with the ground at only about five or six seconds. From evidence of other witnesses the Commissioner thought this to be an underestimate and that the period was probably about twenty seconds.

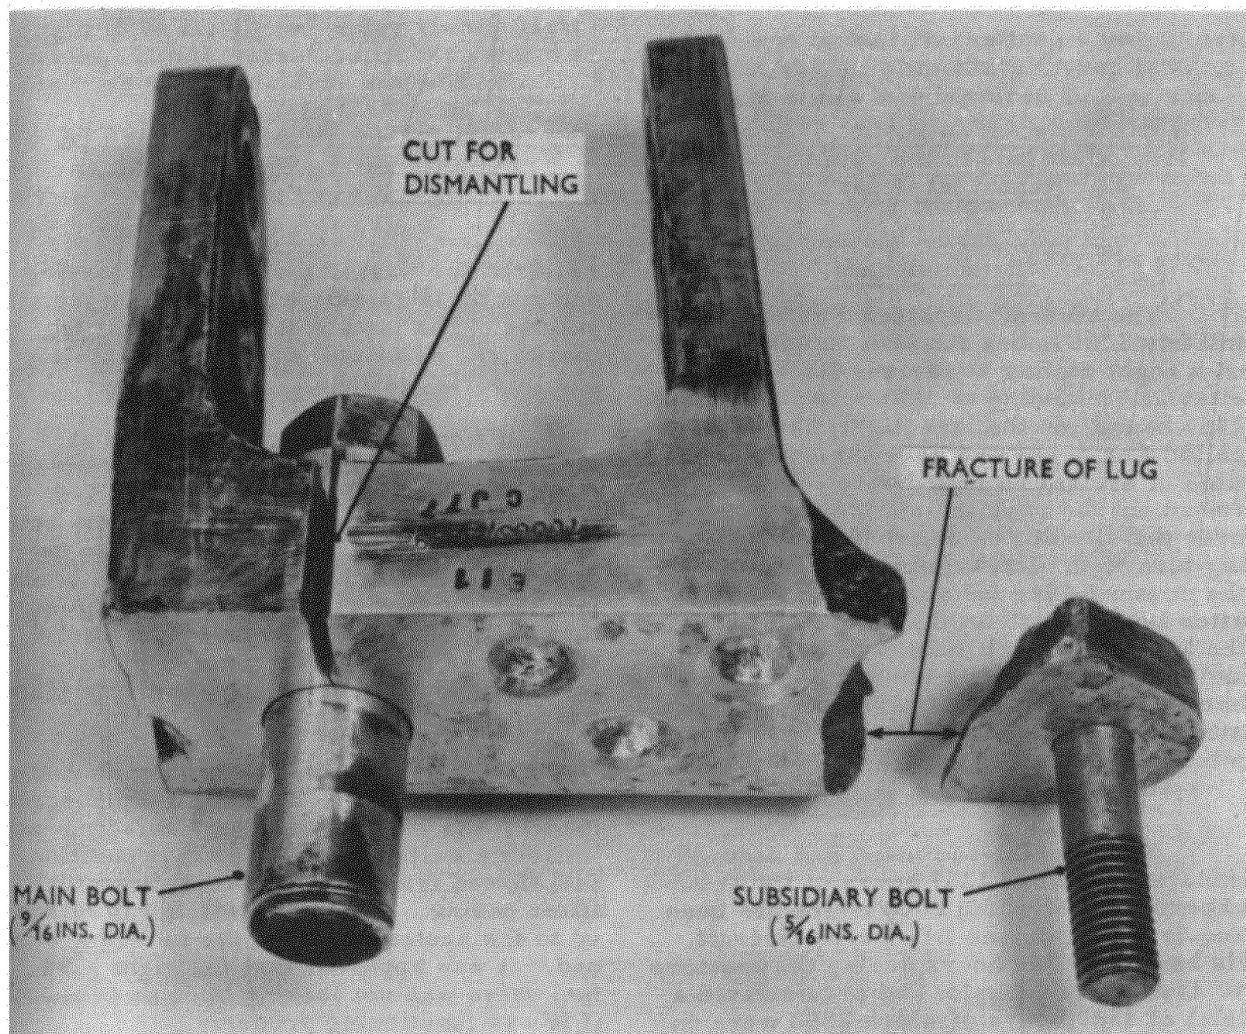
FIGURE 13

From the point of view of this report the important flap unit is starboard flap unit No. 2. The important fitting is the aft lower fitting of that unit (see Figure 13) and the important bolt is the larger bolt through that fitting. This was a 9/16 inch

diameter bolt and the smaller bolt at the same fitting was 5/16 inch. In the wreckage were found the flap unit and the main part of the aft bottom fitting with the head and part of the shank of the 9/16 inch bolt (broken off so as to leave only one thread), while the lug of the fitting was still attached to the trailing edge member by the 5/16 inch bolt. The remainder of the 9/16 inch bolt together with its nut was never found, despite diligent search. The surface of the break in the 9/16 inch bolt showed on examination an appearance which left no doubt in the mind of an expert that the bolt had been subject to fatigue; about 20% of the area appeared to have had a fatigue crack spreading slowly across it, about another 70% showed a more rapid progress of fatigue, and the final 10% had suffered a sudden tension fracture. The break of the lug from the remainder of the fitting cannot be described with particularity because fire had so affected the broken surfaces as to destroy evidence of the metallurgical character of the fracture. When found, the flap unit was completely detached from the wing but the indications were that the top fitting had broken after the lower part of the unit had been detached from the wing, and it seems probable the top fitting broke only in the course of the final break-up of the aircraft.

- c) because the part of the trailing edge member of the wing against which the fitting had to rest had three snap rivet heads projecting from it, three small depressions had been made in the face of the fitting (see Figure 13); but the edge of two of these depressions had fouled their rivet heads so that the face of the fitting had not been lying true against the trailing edge member.

The cause of the accident was the fracture, due to fatigue, of the 9/16 inch bolt holding the bottom of the No. 2 starboard flap unit.

BOTTOM FITTING OF NO. 2 UNIT

- a) that reliance on a single bolt in tension for the support of a primary structure should be avoided if possible;
- b) that where such bolts are used an ample margin of strength should be allowed (having regard to the material of which the bolt is made) so as to ensure that fatigue will not develop at any time in the life of the bolt;
- c) that where such bolts are used the seating of the bolt and nut should be carefully checked.
